# **A Study into the Provision of Sustainable Toilets in Remote Rural Locations**

Forth Valley and Lomond LEADER Local Action Group  
February 2010

## 12.7 CASE STUDY - Sunart Oakwoods – NatSol compost toilet

Sunart Oakwoods,  
Salen,  
Ardnamurchan & Morvern

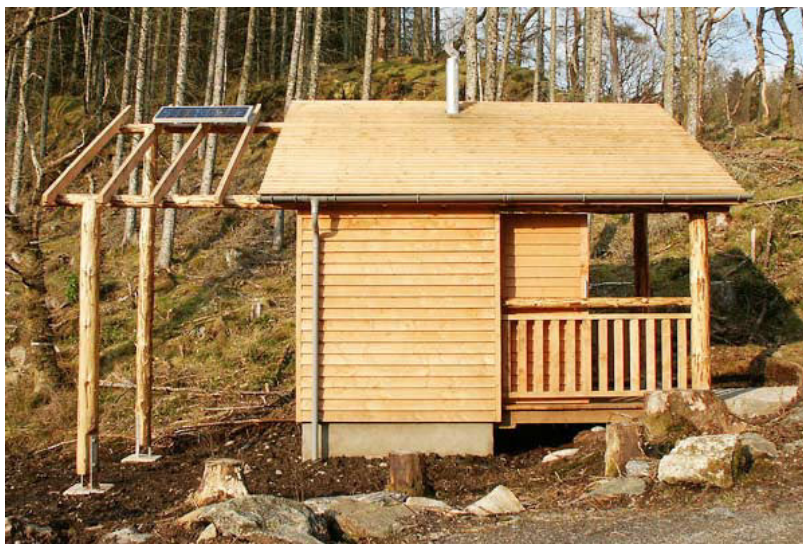
The tiny building was completed in April 2007 and was constructed primarily from Larch and Douglas Fir cladding and horizontal board roof. The roof, footings and balustrade details were designed to match the existing amenity building.

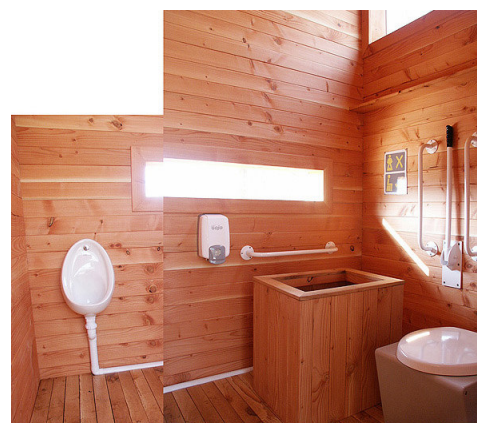
The internal view shows the toilet pedestal on the right. Being a twin vault, this unit swaps annually with the soak bin to its side. A urinal is provided and the timber flooring is removable for access to the chambers beneath.

The building features a sheltered area for prams and a retreat from the rain, while the compost toilet itself is a proprietary model by NatSol.

There is no water supply, so hand cleansing is by anti-bacterial gel. Photovoltaic panels feed a battery to provide light when needed.
